## Application Example for the Use of CoolBLUE®

Damaged bearing of a pump unit due to circular currents

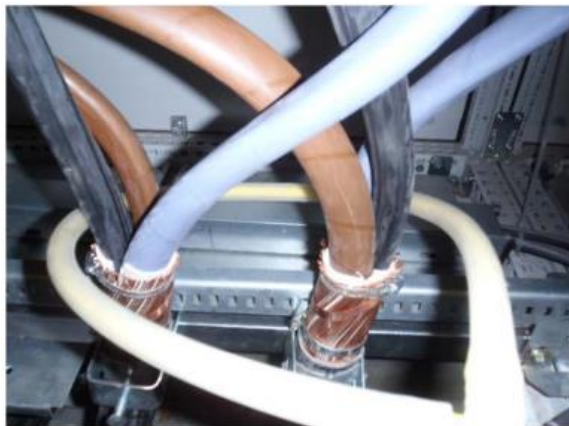
Picture 2,1: Original condition

The measurements were done before and after application of CoolBLUE® Nanocrystalline cores at constant speed, without load.

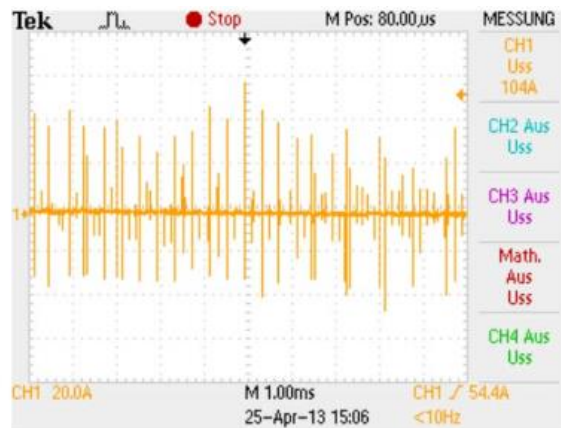
Picture 2,2: CM current at drive output  
20A/Div, 1ms/Div > I<sub>ss</sub> ca. **104 Amps**

Solution: Installed 2 nanocrystalline CoolBLUE® tape wound cores  
Part number - CBO326HP1632+A23

By using 2 CoolBLUE® Nanocrystalline cores, CBO326HP1632+A23, from MH&W, per drive peak-peak value of the CM current on the motor reduced from 104Amps to 17Amps...factor of 6!  
Additionally, the shaft voltage – measured as peak-peak value reduced from 10V to 5.5V, and the number of peaks were significantly lower.

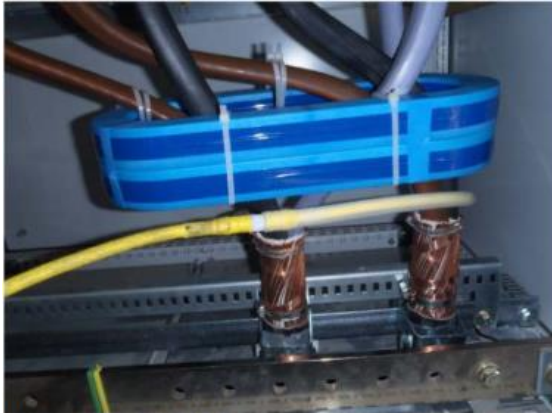
Picture 3,1: Use of 2 cores CBO326HP1632+A23

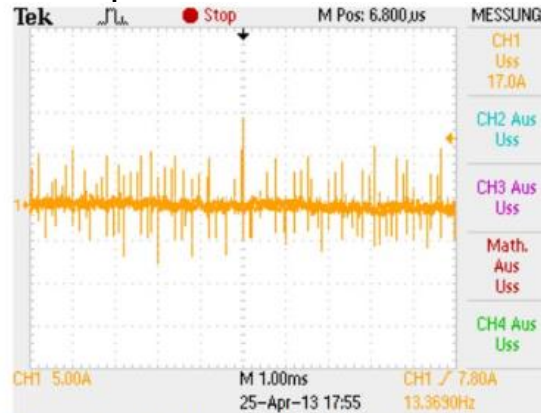
Picture 3,2: 5A/Div, 1ms/Div > I<sub>ss</sub> ca. **17 Amps**

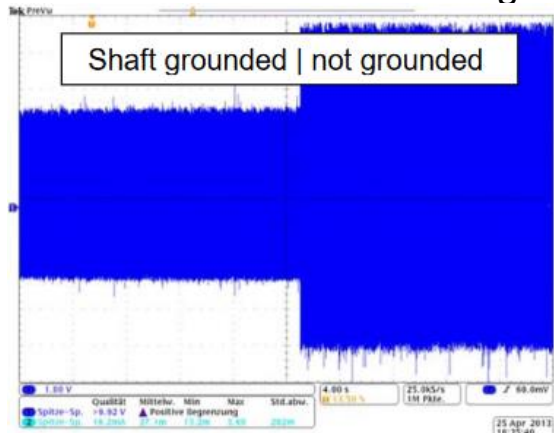
Picture 4: Original condition  
1V/Div > U<sub>ss</sub> max ca. **10 V**

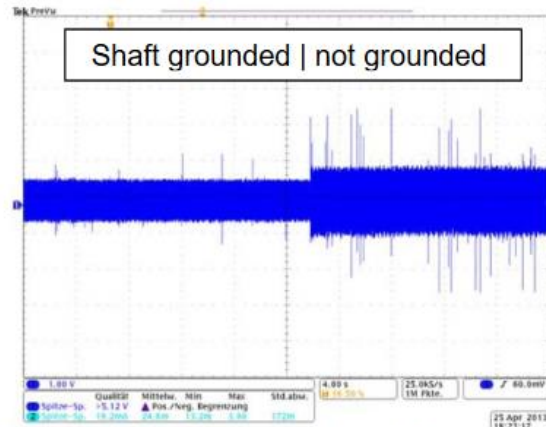
Picture 5: Use of 2 cores CBO326HP1632+A23  
1V/Div > U<sub>ss</sub> ca. **5,5 V**
