Analysis of Motor Shaft Voltages and Currents

Variable Frequency Drive is from an European Manufacturer 0,75 kW

Motor is a 1 kW Asynchronous machine

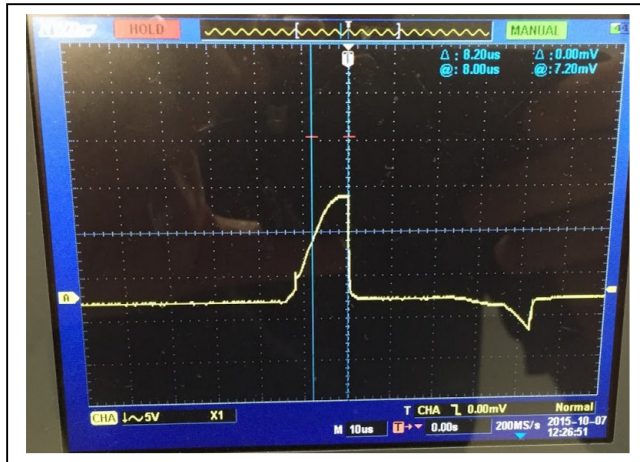
In the next picture you can see the Voltage versus Time behaviour

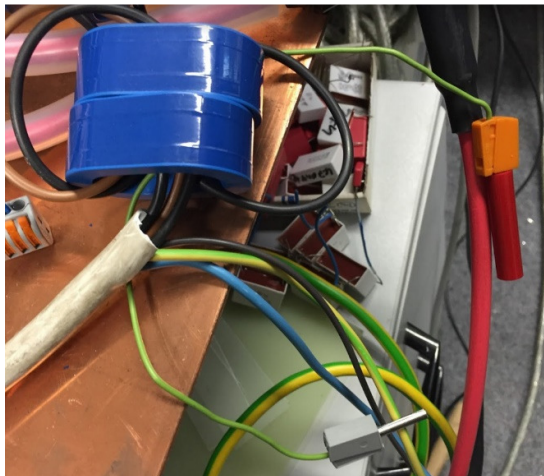
Important is, that the CoolBlue Cores and NaLA are in and they are not deactivated.

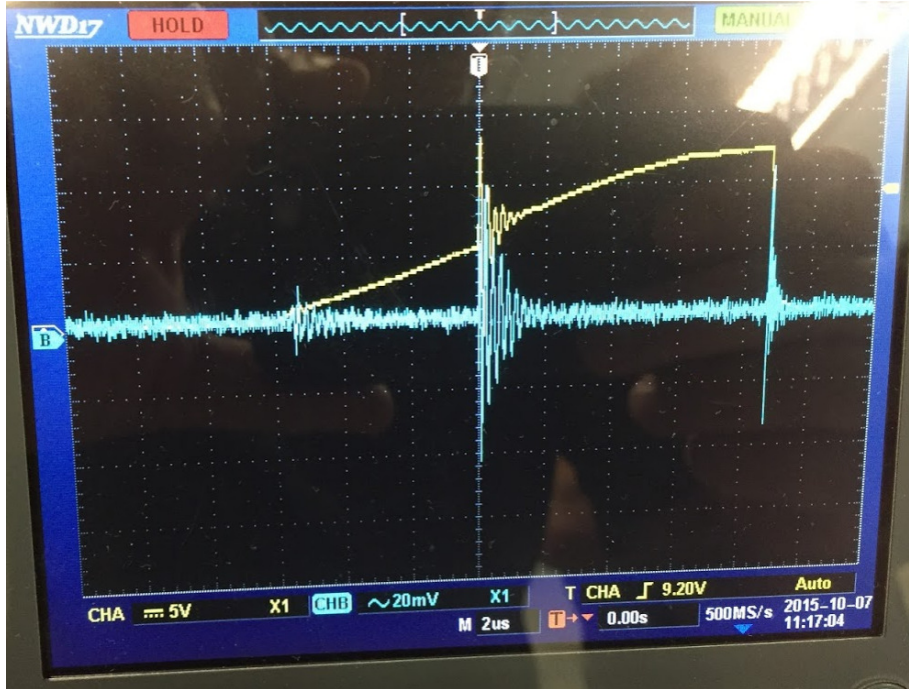
With an increase Current resolution we can see the very intensive High Frequency behaviour of the Current with the deactivated CoolBlue Cores
