# Installation of CoolBlue Inductive Absorbers and Common Mode Current Measurement – Parc Riviera Pump Station

Vibes Corp - Parc Riviera: Pump #1

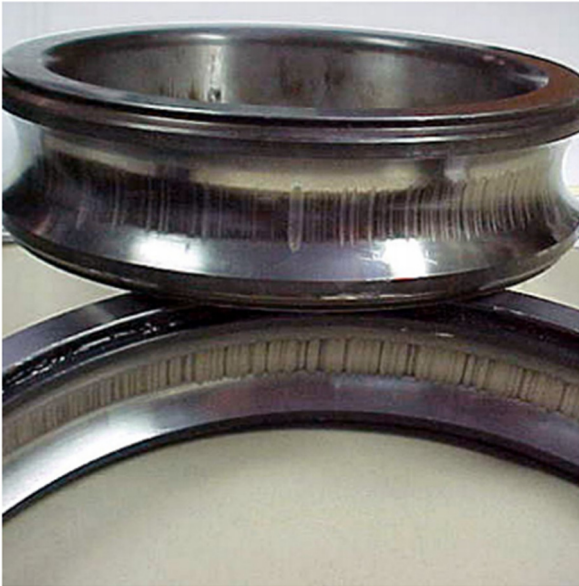
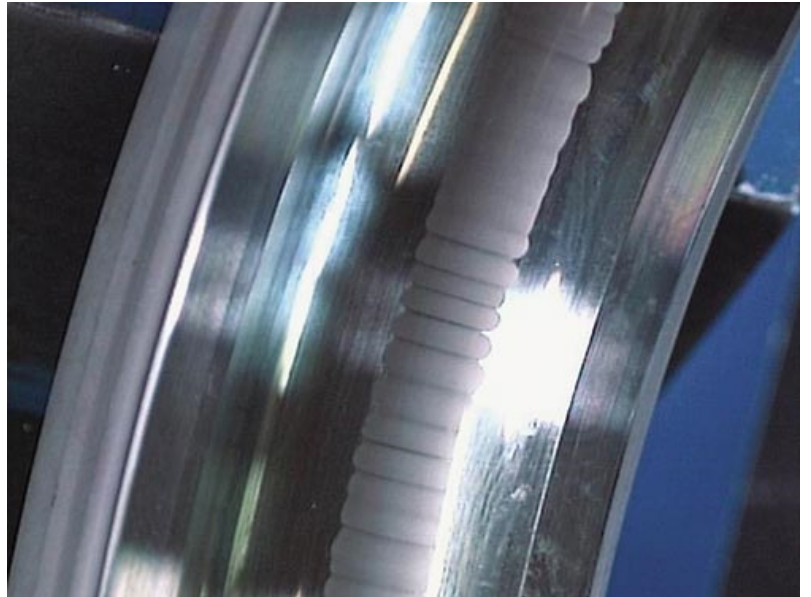
Typical bearing fluting caused by EDM

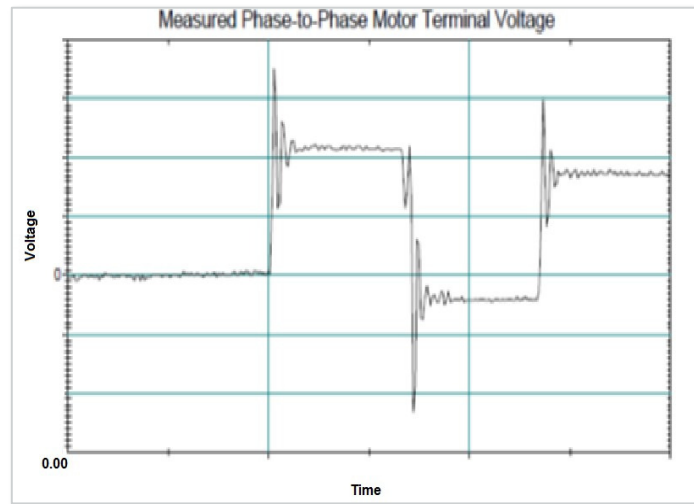
Each pulse in a PWM system is not a clean square pulse. Each Rise and Fall of the pulse has an over shoot or transient over-voltage. This over-voltage phenomenon is also known as "Reflected Wave", "Transmission Line Effect" or "Standing Wave".

The per unit overvoltage magnitude is dependent upon drive-cable-motor circuit dynamics defined by drive output voltage magnitude and rise time, cable surge impedance characteristics, motor surge impedance to the pulse voltage, cable length and spacing of the train of pulses by the PWM modulator.

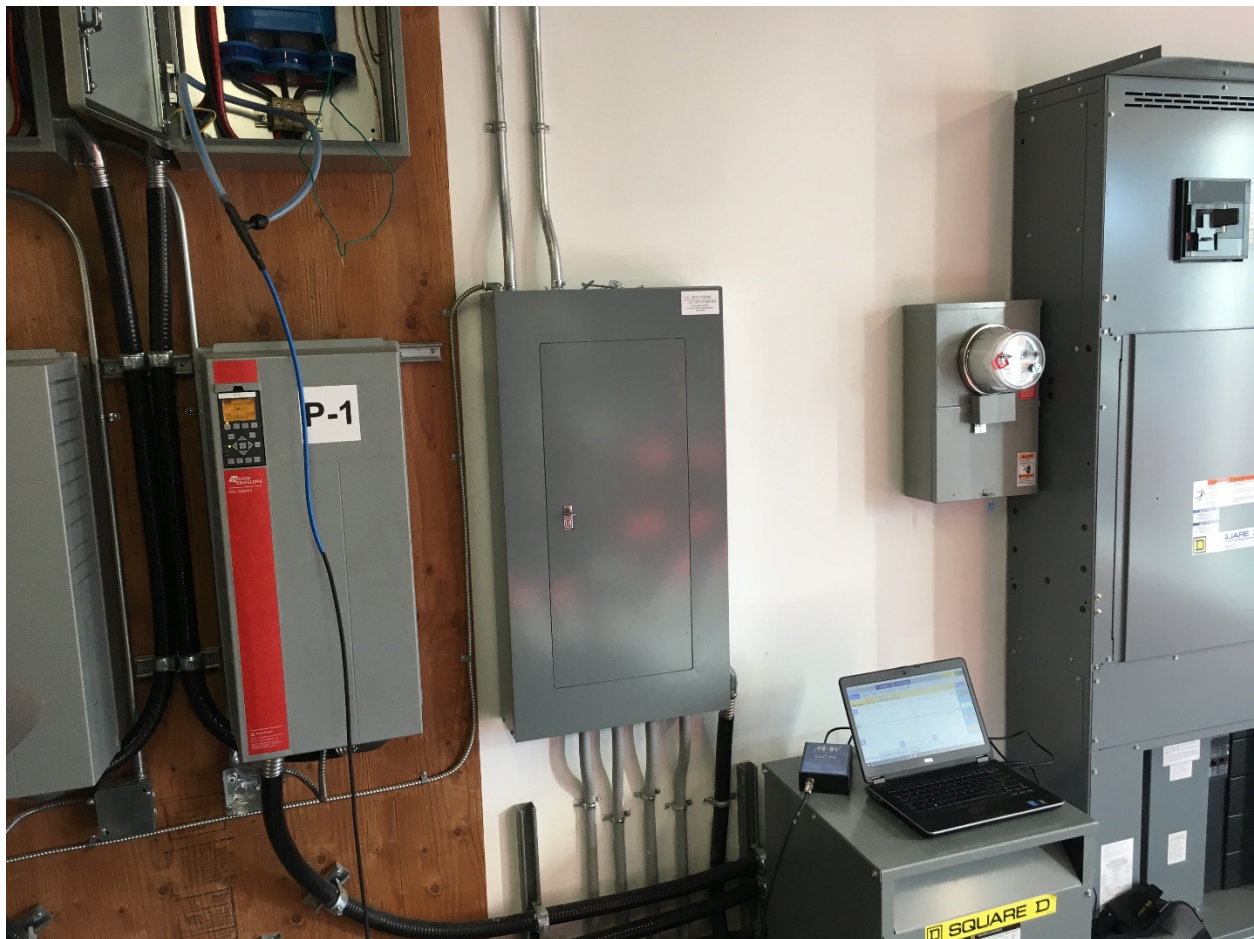
The simplest and safest way to measure common mode current is with a flexible, clip-around, Rogowski coil. This method is used to measure high frequency destructive common mode currents in motor drives . . . high frequencies produced by motor drive IGBT's in the kHz up to several MHz's.

The high frequency Rogowski coil simply connects around the 3 power phases of cable going from the drive to the motor to measure common mode current. If multiple cables per phase, coil would still go around all cables. The output of the Rogowski coil connects to the DCM 100, and measures the common mode current.

Simply power down, place the Rogowski coil around 3 phases of power.

Power up system. Measure current.

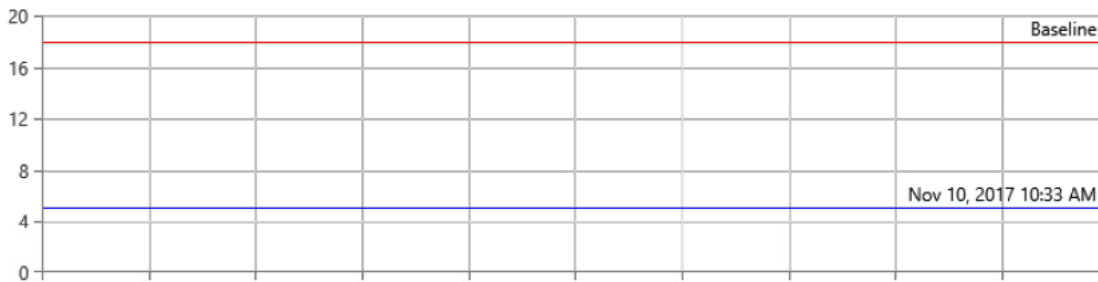
<u>Date Recorded</u>	<u>Peak Spike</u>	<u>Reduction</u>	<u>Avg Spike</u>	<u>Reduction</u>
Nov 10, 2017 10:27 AM	17.92 Amps	BASELINE	3.91 Amps	BASELINE
Nov 10, 2017 10:33 AM	5.07 Amps	-72%	1.86 Amps	-52%

### BASELINE DATA

**Peak Current Spike:** 17.92 Amps

- Common mode peak currents measured since the installation of CoolBlue® Inductive Absorbers and NALA differential line absorbers are well below the recommended levels
- Peak Current reductions are as follows
  - Pump #1 – 72%
  - Pump #2 – 73%
  - Pump #3 – 59%
  - Pump #4 – 63%
- As well as the amplitude of the current being reduced, the frequency observed has slowed down significantly, and subsequent ringing in the lines after the peak spikes has almost been eliminated

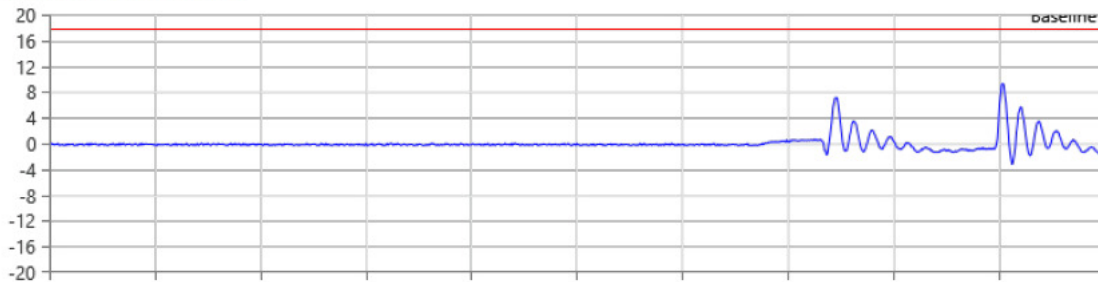
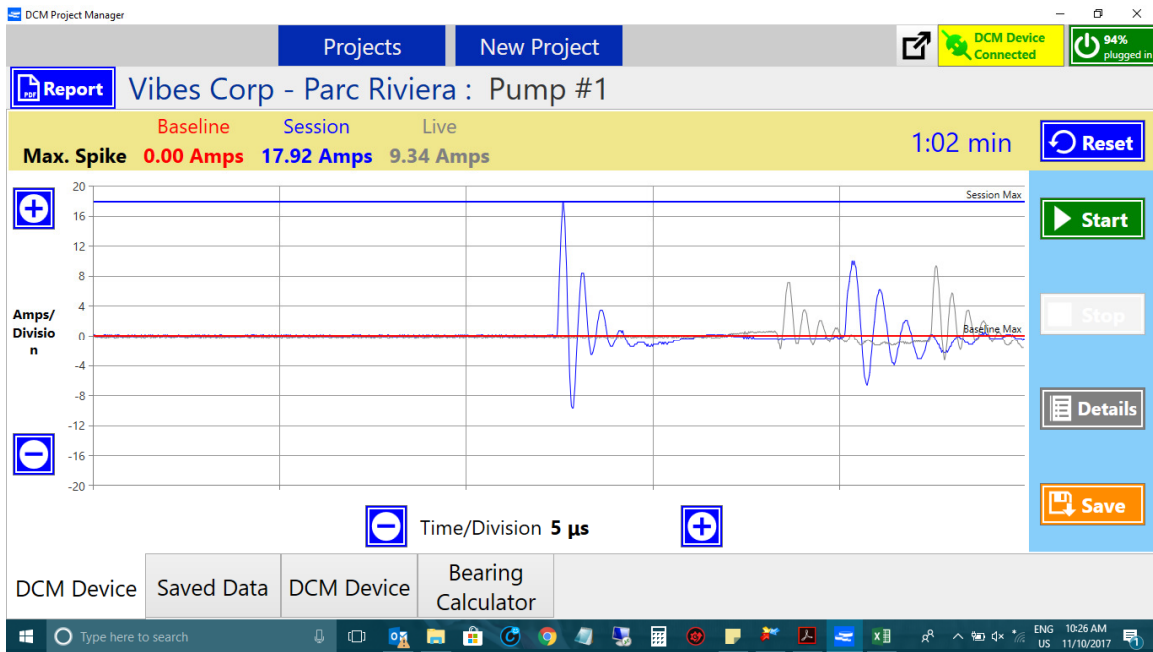
Baseline Snapshot

**Average Current Spike:** 3.91 Amps

**Time/Div:** 5 μs

**Notes:** CoolBlue Defeated

Bearing Number	6316	
Ball Diameter (mm)	28.58	
Peak Current (A)	17.92	
Current Density (A/mm <sup>2</sup> )	0.2	Fail*
Maximum Allowable Current (A)	13.46

Bearing Number	6314	
Ball Diameter (mm)	25.40	
Peak Current (A)	17.92	
Current Density (A/mm <sup>2</sup> )	0.2	Fail*
Maximum Allowable Current (A)	11.96

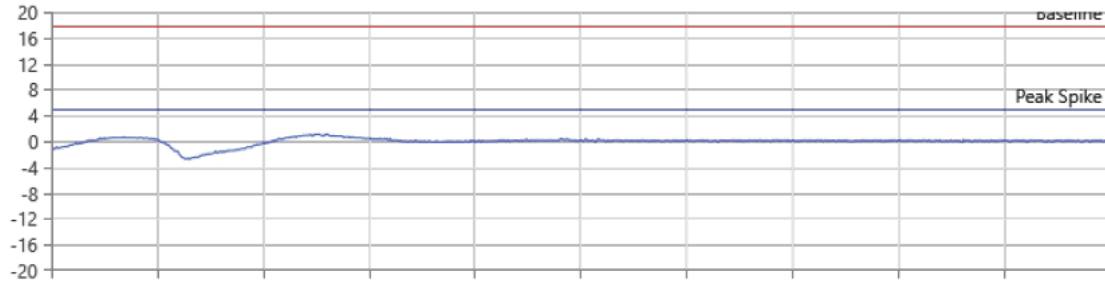
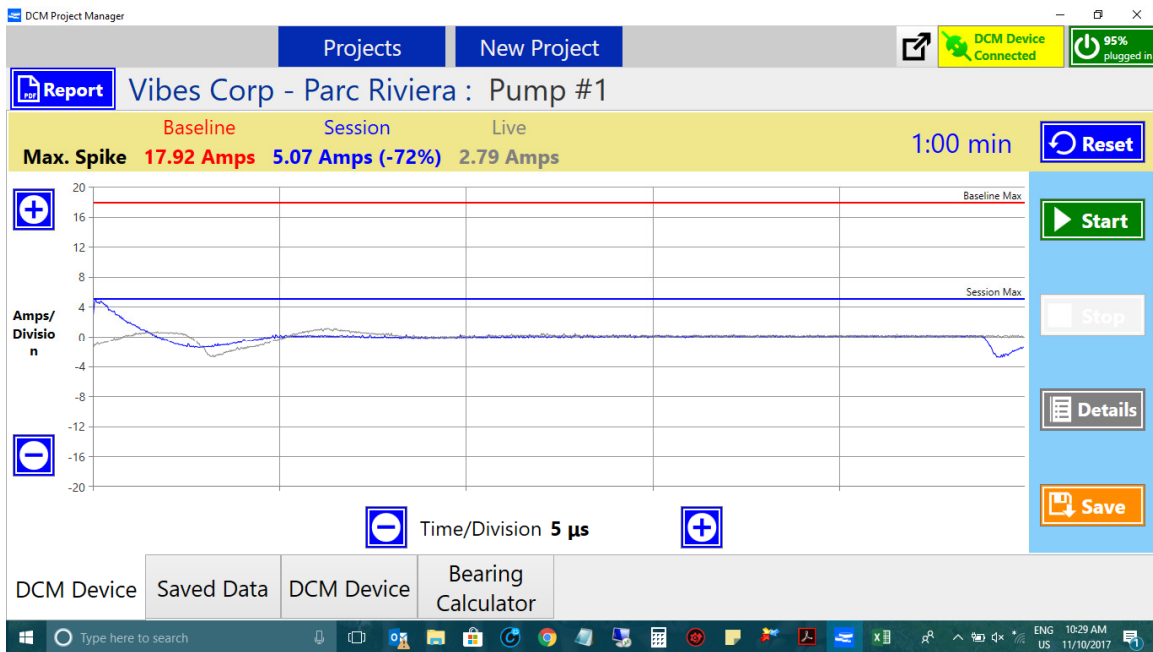
Snapshot After CoolBlue® Installation

**Peak Current Spike:** 5.07 Amps (-72%)

**Average Current Spike:** 1.86 Amps (-52%)

**Notes:** CoolBlue Installed

Bearing Number	6316	
Ball Diameter (mm)	28.58	
Peak Current (A)	5.07	
Current Density (A/mm <sup>2</sup> )	0.1	Pass*
Maximum Allowable Current (A)	13.46

Bearing Number	6314	
Ball Diameter (mm)	25.40	
Peak Current (A)	5.07	
Current Density (A/mm <sup>2</sup> )	0.1	Pass*
Maximum Allowable Current (A)	11.96

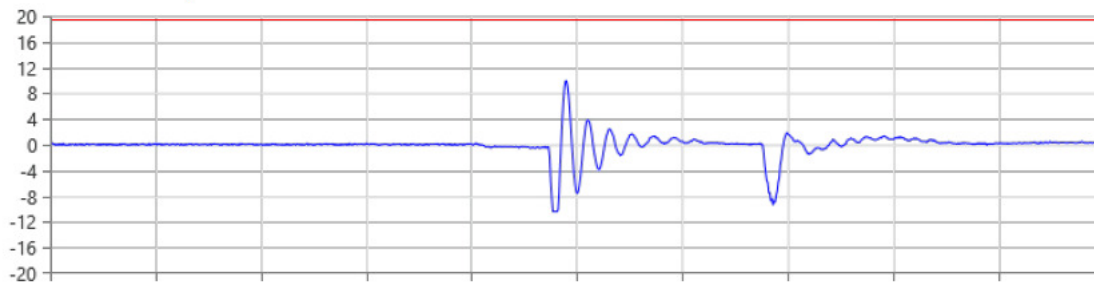
Baseline Snapshot

**Peak Current Spike:** 19.62 Amps

**Average Current Spike:** 4.19 Amps

**Notes:** CoolBlue Defeated

Bearing Number	6316	
Ball Diameter (mm)	28.58	
Peak Current (A)	19.62	
Current Density (A/mm <sup>2</sup> )	0.2	Fail*
Maximum Allowable Current (A)	13.46

Bearing Number	6314	
Ball Diameter (mm)	25.40	
Peak Current (A)	19.62	
Current Density (A/mm <sup>2</sup> )	0.2	Fail*
Maximum Allowable Current (A)	11.96

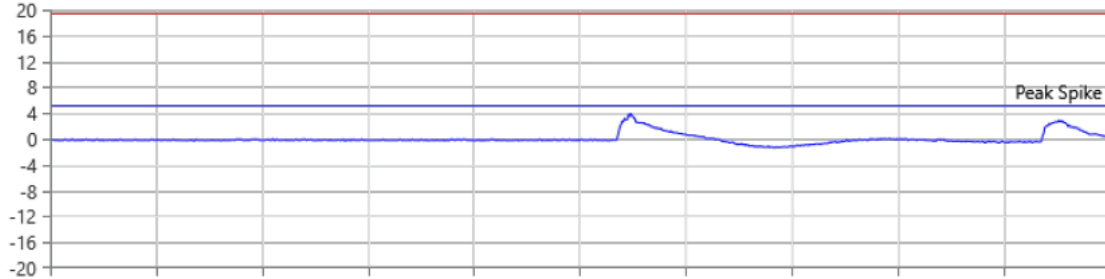
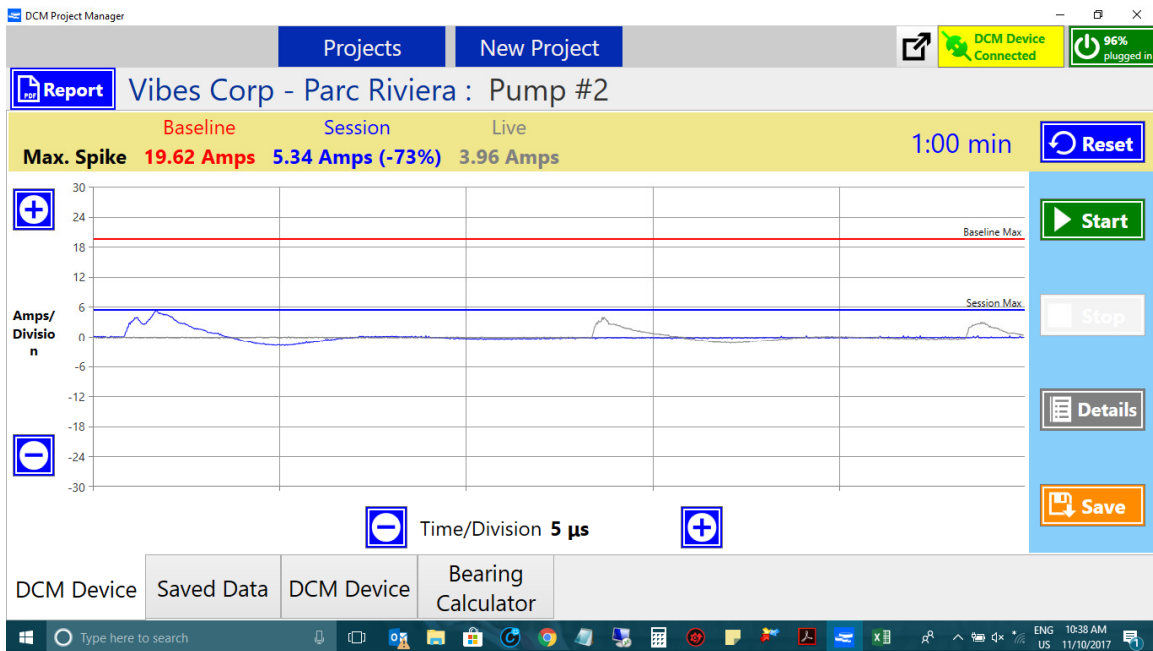
Snapshot After CoolBlue® Installation

**Peak Current Spike:** 5.34 Amps (-73%)

**Average Current Spike:** 2.03 Amps (-51%)

**Notes:** *CoolBlue Installed*

Bearing Number	6316	
Ball Diameter (mm)	28.58	
Peak Current (A)	5.34	
Current Density (A/mm <sup>2</sup> )	0.1	Pass*
Maximum Allowable Current (A)	13.46

Bearing Number	6314	
Ball Diameter (mm)	25.40	
Peak Current (A)	5.34	
Current Density (A/mm <sup>2</sup> )	0.1	Pass*
Maximum Allowable Current (A)	11.96

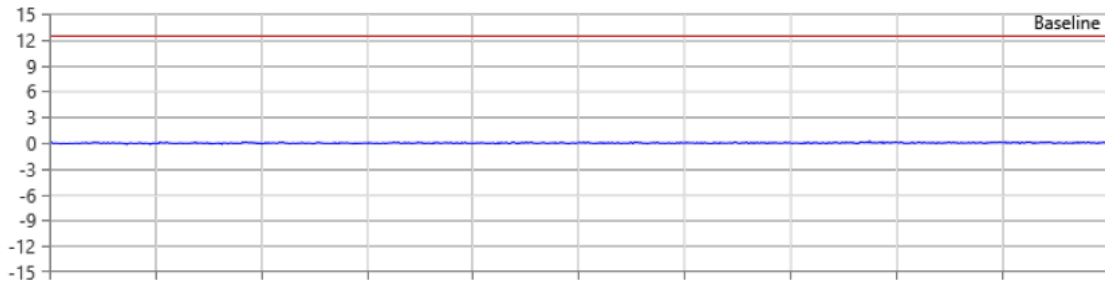
Baseline Snapshot

**Peak Current Spike:** 12.57 Amps

**Average Current Spike:** 2.60 Amps

**Notes:** CoolBlue Defeated

Bearing Number	6313	
Ball Diameter (mm)	23.80	
Peak Current (A)	12.57	
Current Density (A/mm <sup>2</sup> )	0.2	Fail*
Maximum Allowable Current (A)	11.21

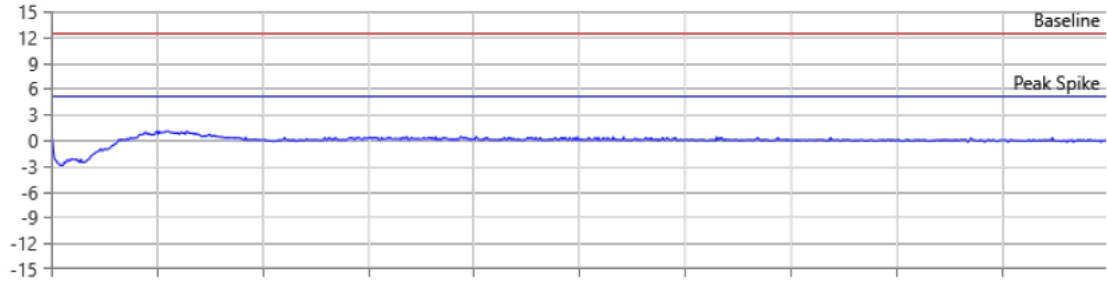
Snapshot After CoolBlue® Installation

**Peak Current Spike:** 5.20 Amps (-59%)

**Average Current Spike:** 1.29 Amps (-50%)

**Notes:** CoolBlue Installed

Bearing Number	6313	
Ball Diameter (mm)	23.80	
Peak Current (A)	5.20	
Current Density (A/mm <sup>2</sup> )	0.1	Pass*
Maximum Allowable Current (A)	11.21

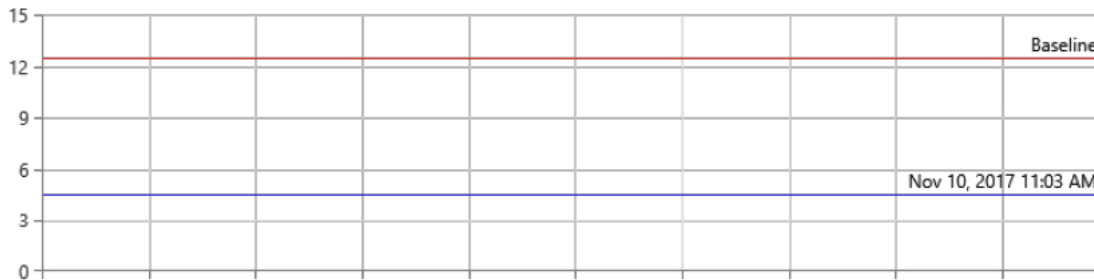
Date Recorded	Peak Spike	Reduction	Avg Spike	Reduction
Nov 10, 2017 11:01 AM	12.53 Amps	BASELINE	5.05 Amps	BASELINE
Nov 10, 2017 11:03 AM	4.59 Amps	-63%	1.87 Amps	-63%

### BASELINE DATA

**Peak Current Spike:** 12.53 Amps

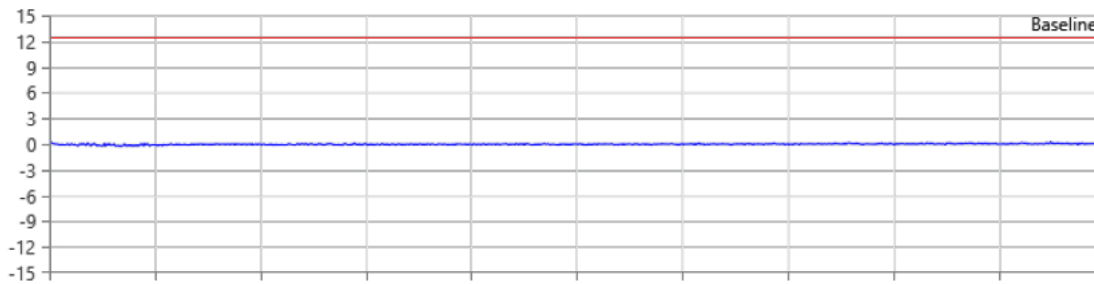
Baseline Snapshot

**Average Current Spike:** 5.05 Amps

**Notes:** CoolBlue Defeated

Bearing Number	6314	
Ball Diameter (mm)	25.40	
Peak Current (A)	12.53	
Current Density (A/mm <sup>2</sup> )	0.2	Fail*
Maximum Allowable Current (A)	11.96

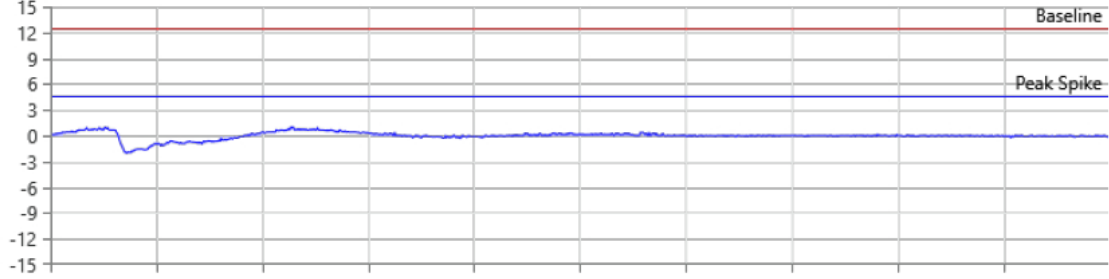
Snapshot After CoolBlue® Installation

**Peak Current Spike:** 4.59 Amps (-63%)

**Average Current Spike:** 1.87 Amps (-63%)

**Notes:** *CoolBlue Installed*

Bearing Number	6314	
Ball Diameter (mm)	25.40	
Peak Current (A)	4.59	
Current Density (A/mm <sup>2</sup> )	0.1	Pass*
Maximum Allowable Current (A)	11.96
